## CASE STUDY Multi-Utility A2A in the City of Brescia, Italy

# How water leakage was reduced in bulk with Curapipe's Trenchless Automated Leakage Repair (TALR) system

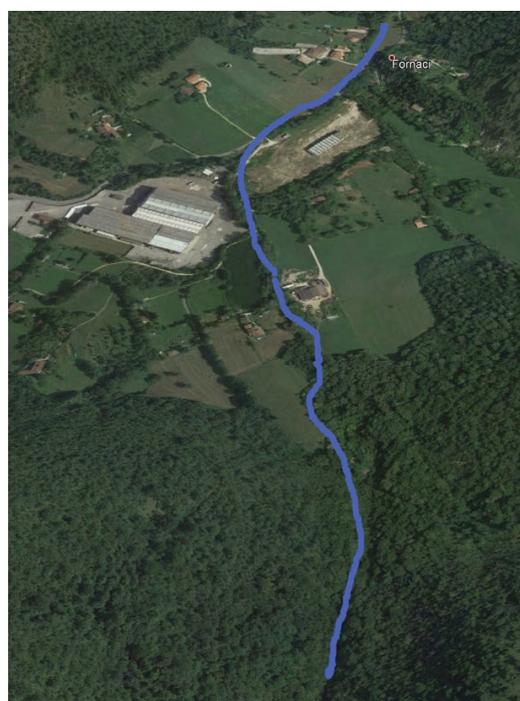
*In this case, the challenge was to significantly reduce the high level of multi-source leakage (2.8 l/s) within a three-day timeframe without knowing where the specific leaks were located.*

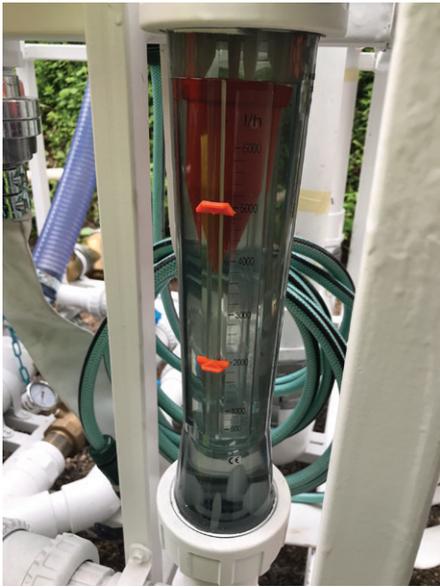
*In the first pipe section, measurements taken during sealing cycles indicated the presence of four leaks spaced along the route. The leakage levels were 1,700 l/h, 500 l/h, 4,800 l/h and 1,900 l/h respectively totaling 8,900 l/h.*

*Following its sealing cycles, TALR was able to reduce these leakages to **ZERO**!*
